Evaluation and Prioritization of Erosion Protection Measures along the Coast of Avlida

A detailed investigation of the erosion phenomenon taking place in the coastal front (coastline) from Avlida beach to Vathi region in the Municipality of Chalkida is presented. Based on the assessment of existing erosion problems and an evaluation of short/medium-term effects on the terrestrial and marine environment, a prioritization of immediate actions - measures will be proposed to ensure protection of the existing infrastructure. Emphasis will be given to analyze the evolution of erosion phenomenon under climate change scenarios due to high tourist value of the region.

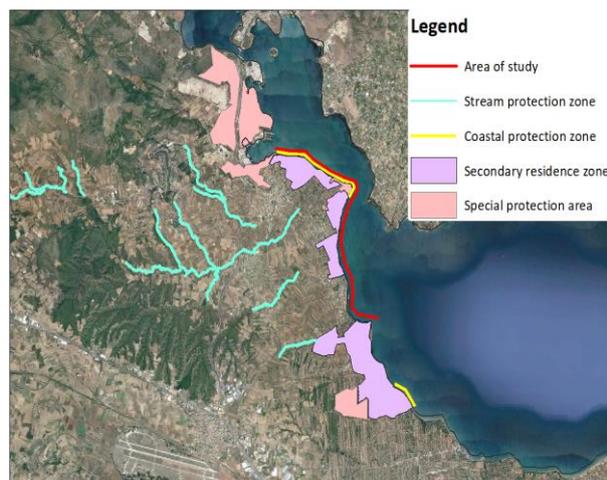
Map 1. Area of Study and land Uses

The coastal zone of the area under study in approximately 6.5 km long surrounded by Avlida Gulf and it is mainly characterized as secondary residence zone (Map 1).

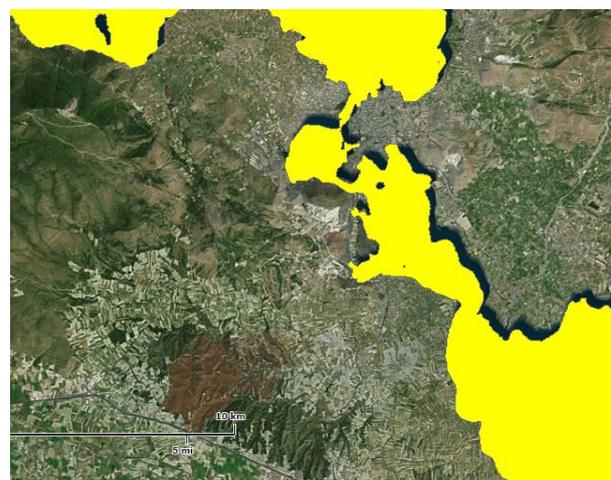
The ecological status (Map 2) of marine water is characterized as moderate (marked in yellow) (www.eea.europa.eu). The environmental pressures that affect the ecological status of the area are mainly related to the industrial and agricultural activities occurred in the greater region.

Map 2. Ecological status of Avlida Gulf
(www.eea.europa.eu)

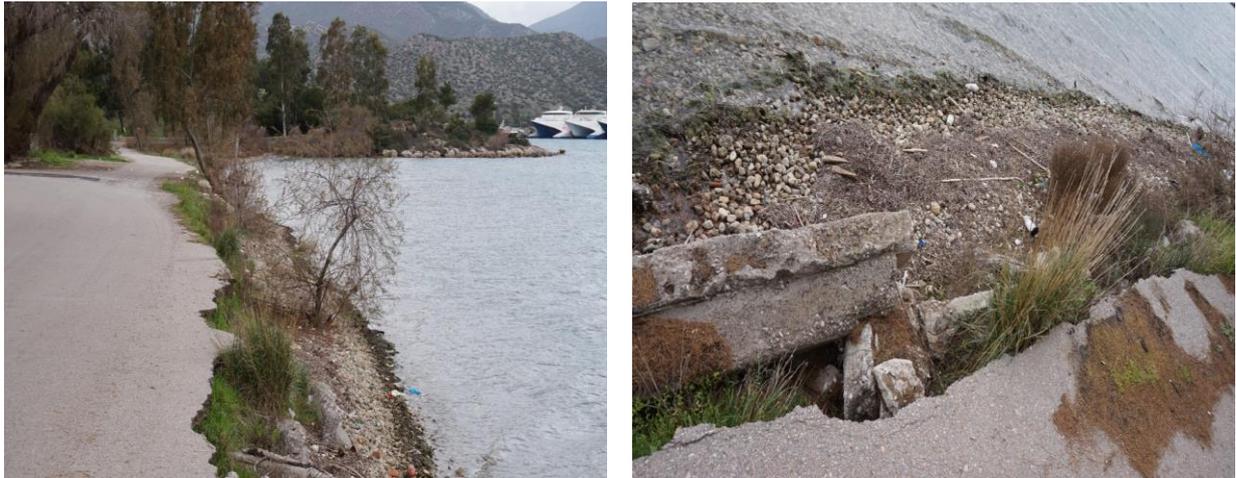
Figure 1. Evidence of erosion along the coastal front of the area under study

phenomenon along the coast. Besides, due to the residential development and the construction of a coastal road, erosion phenomena were evident, as shown in Figure 1.

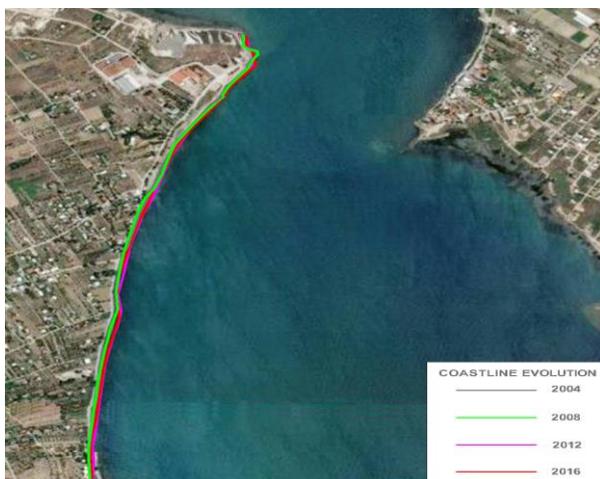
The analysis of historical aerial photographs from 2004 to 2016 (Map 3) proved the evolution of erosion

Map 3. Erosion analysis based on aerial photos

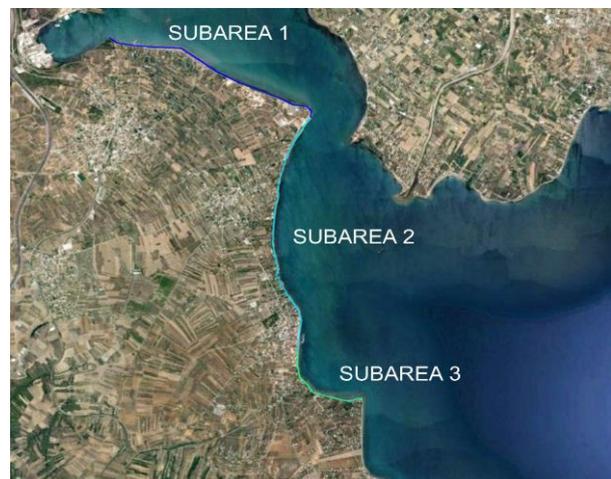
The entire area of interest is subdivided into 3 distinctive individual areas, each one with special features, depending on erosion conditions as well as on land uses and the priority of the necessary mitigation measures of erosion that should be taken (Map 4).

Map 4. Sub division of the Area of Study

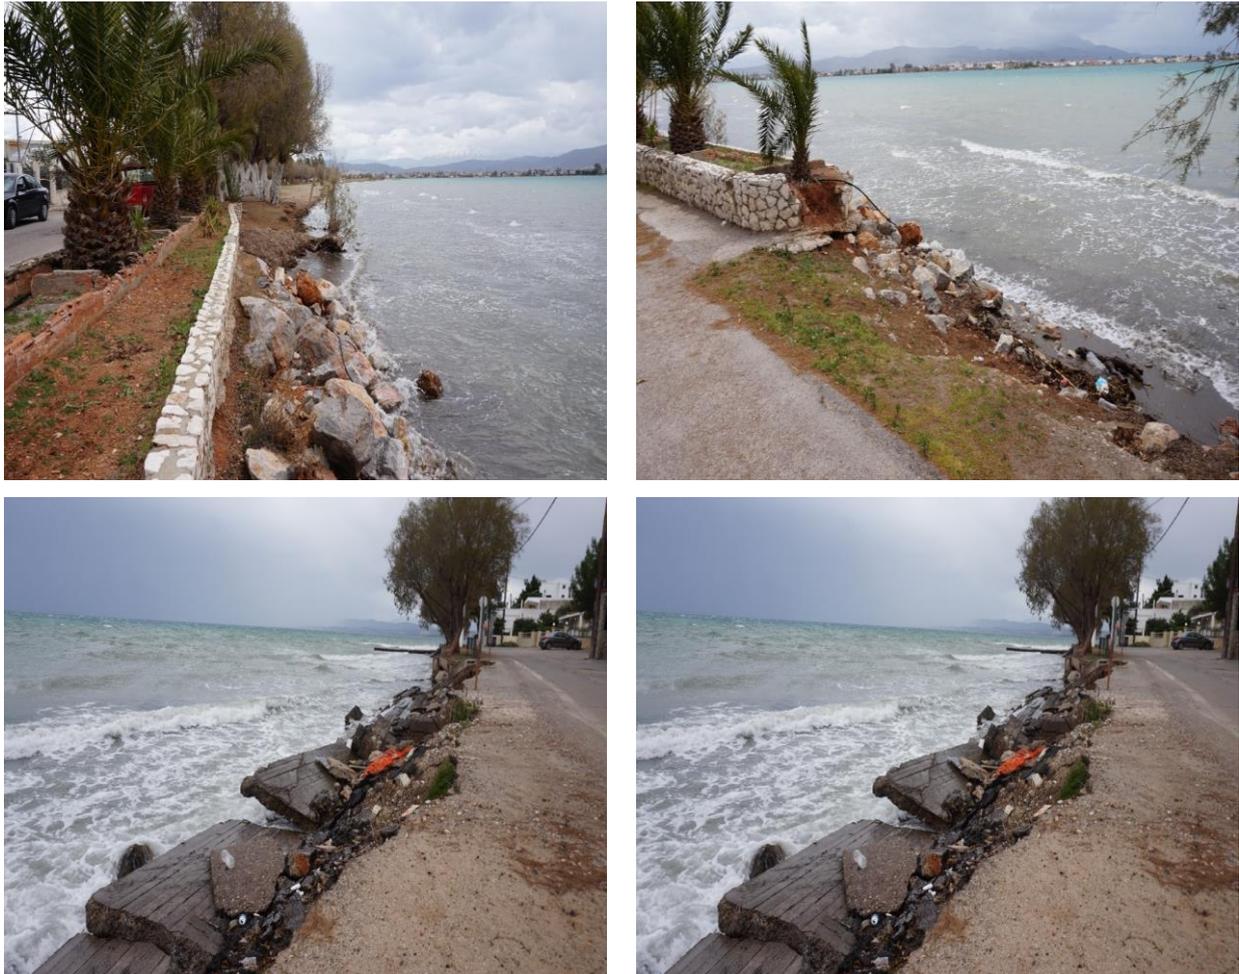
The coastal protection works built, most of them arbitrarily, have failed both constructionally and functionally (Figures 2).

Figure 2. Evidence of damage to the coastal road due to erosion
